# Completion Report

**Client:** Mountain Empire USD

**Facility:** Campo Elementary School

Title	Garland LiquiTec Fluid-Applied Roof System
-------	--

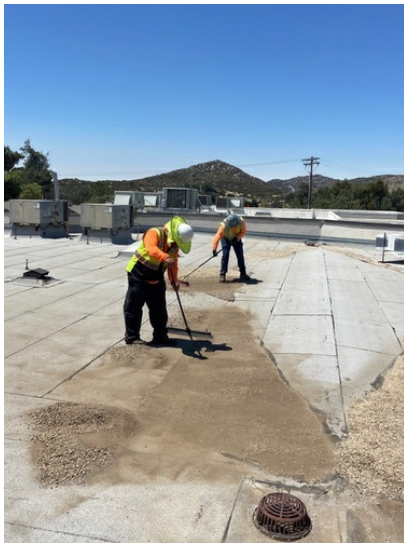
*Photo 1*

Aggregate was removed from the roof.

It has previously been installed by in-house maintenance on the low points of the roof to defend against ponding water.
