Asbestos Survey Report

Address: 3291 Buckman Springs Road, Pine Valley, CA 91962
Prepared by: XRF Research, Inc.
Client: Mountain Empire Unified School District
Date of Report: December 16, 2022
Date of Inspection: November 29, 2022
Consultant: Dylan Victor, CA Cert. Asbestos Consult. #22-7071
Hygienist: Diego Cruz-Baker, CA CSST #18-6191
Hygienist: Paul Rozzi, CA CSST #10-4618

Re: Asbestos Survey of 3291 Buckman Springs Road, Pine Valley, CA 91962,
limited to: Building C and Bungalows P1-P4

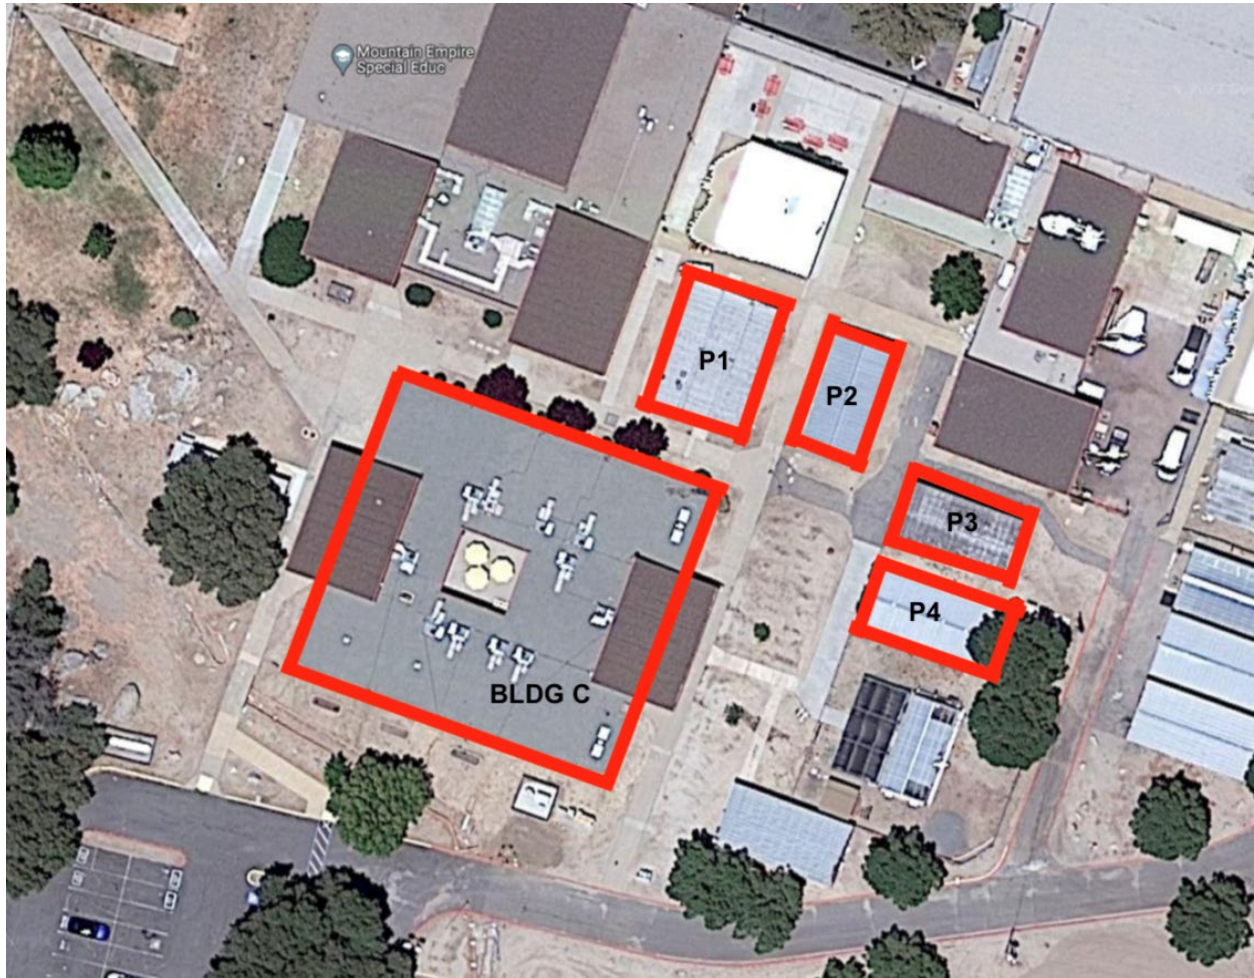
Figure 1. The Diagram below shows the approximate floor plan.

Overview of the buildings inspected

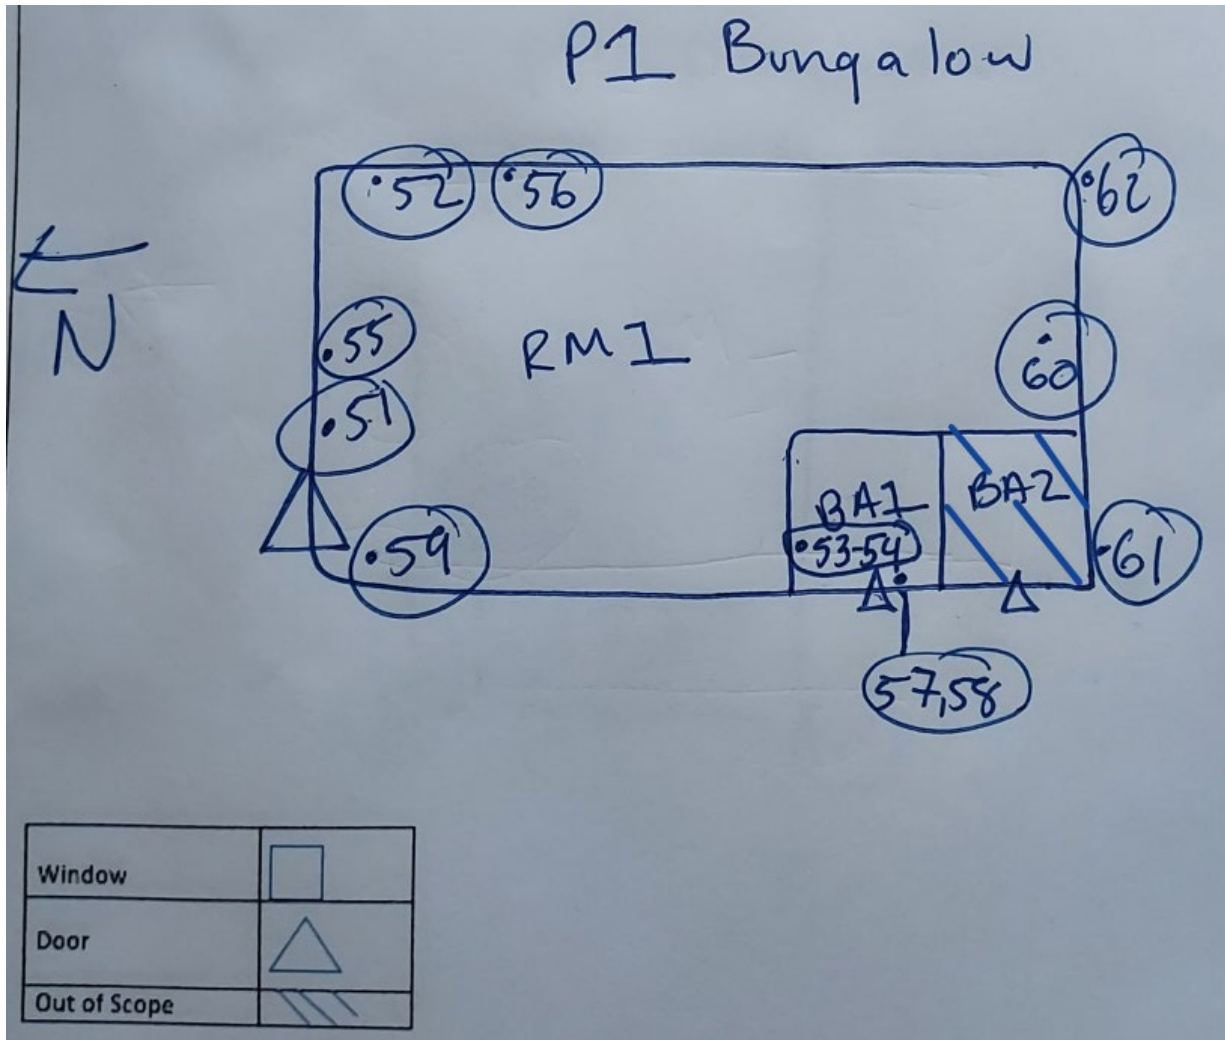
Bungalow P1 floorplan (with approximate samples locations).

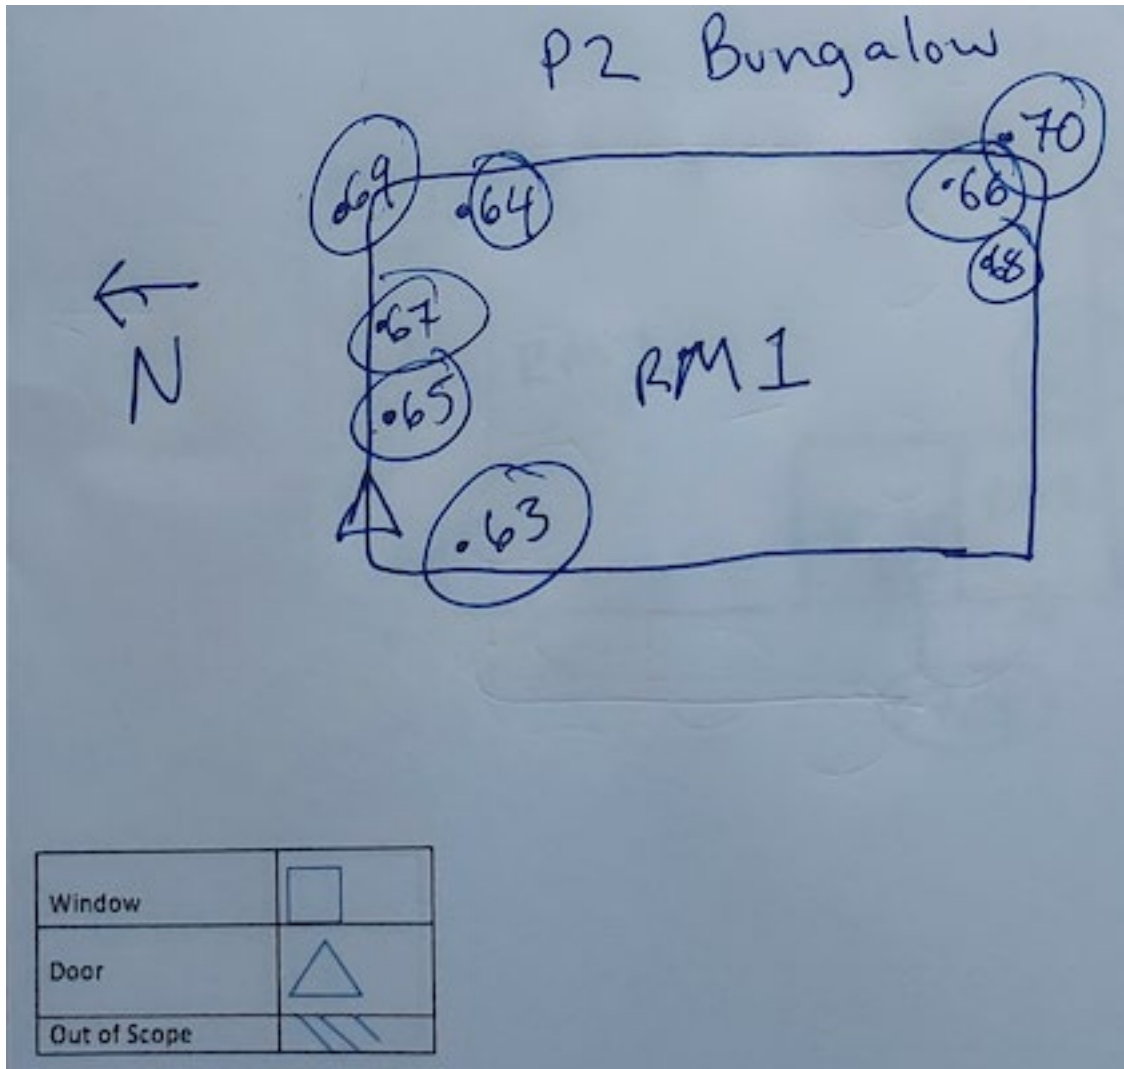
Bungalow P2 floorplan (with approximate samples locations).

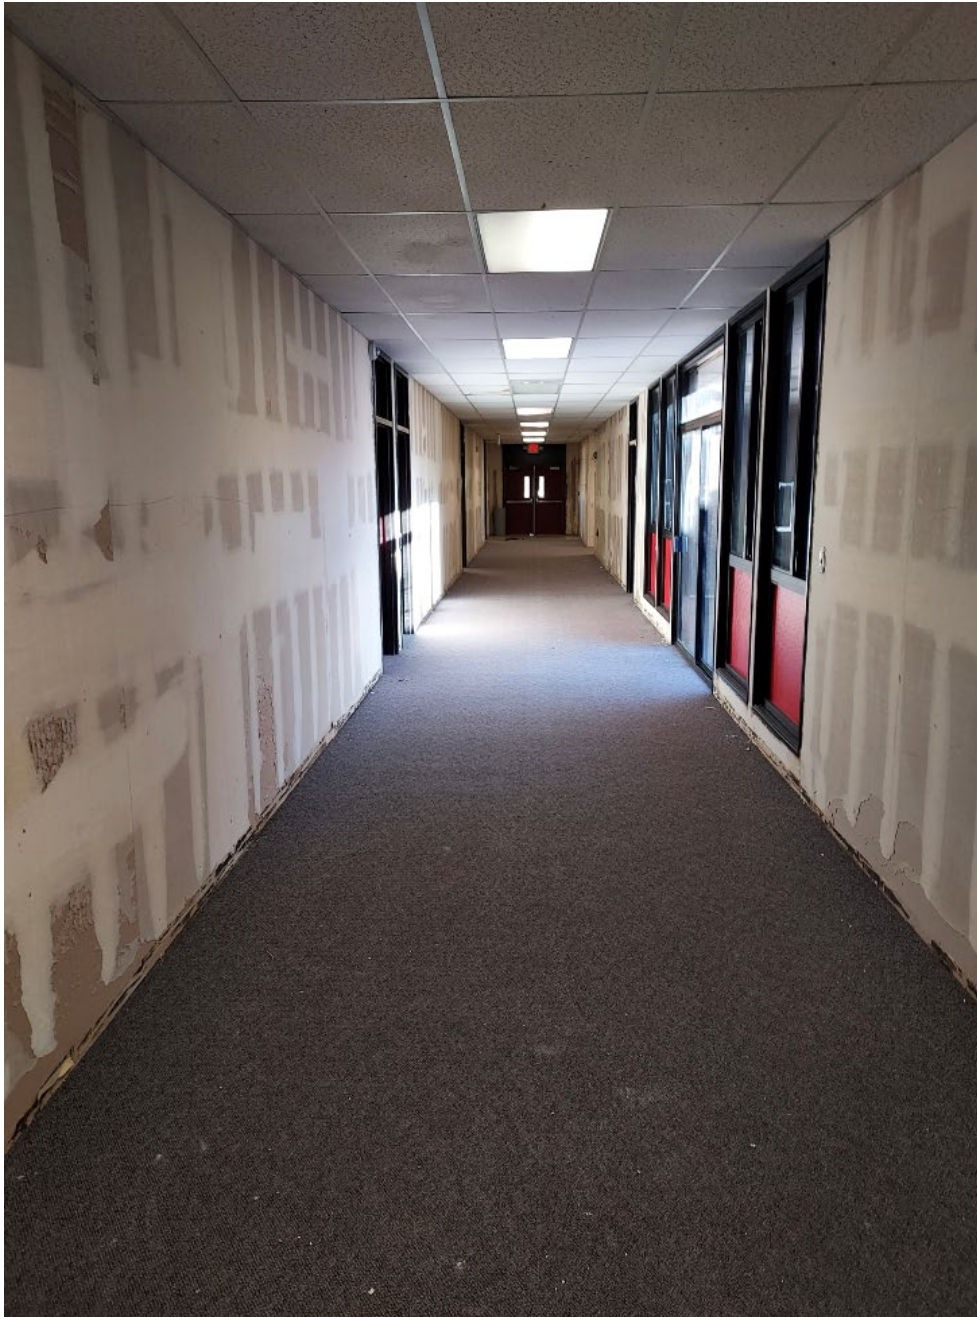
- This commercial building was unoccupied with signs of damage throughout (Picture, §6.0-a)
- Carpet floors were present throughout the building except in the closets and bathrooms. Concrete was observed beneath the carpet flooring

a) Unfinished drywall in building C

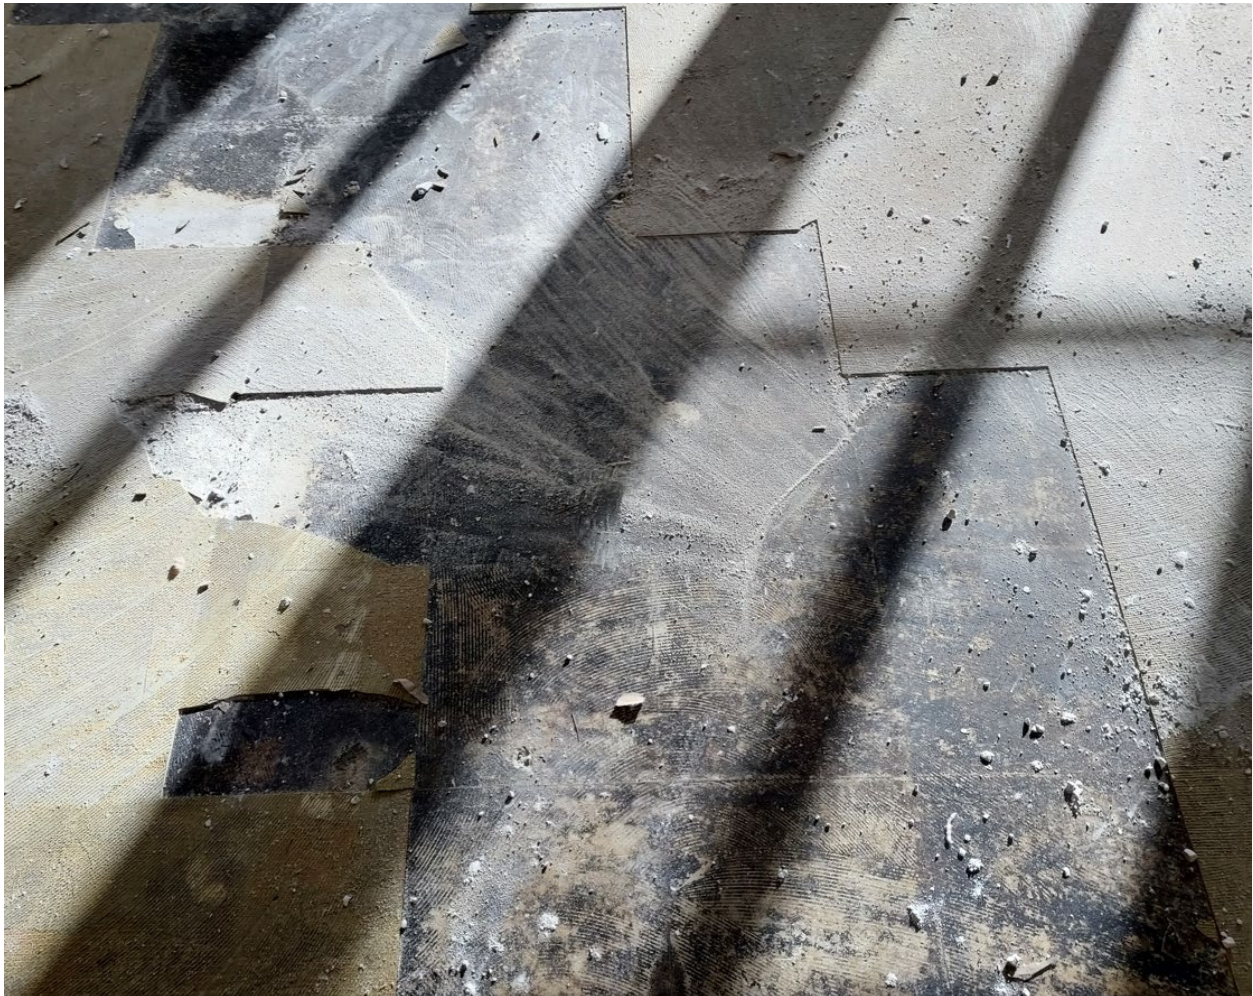
- Multi-colored vinyl floor tiles were observed beneath the carpet flooring in Room 9 and Room 12.
 - *This component contained 2% chrysotile asbestos* (Picture, §6.0-b)

b) Multi-colored vinyl floor tiles in Building C, Room-9 and Room-12

- 1) These vinyl floor tiles were found to contain asbestos.*
- 2) The vinyl floor tiles were found to be damaged and debris was observed in these rooms upon initial inspection.*

- If asbestos-containing materials are to be disrupted or removed as part of demolition, renovation or building repairs, the work should only be done by personnel or contractors who are appropriately trained and licensed. Measures should be taken to control emissions of asbestos fibers that include, but are not limited to use of containment, wet methods, HEPA vacuum and air filtration systems, and deactivation/isolation of HVAC systems. Relevant regulations include EPA (40 CFR 61.145-Standard for Demolition and Renovation), OSHA 3096 (Asbestos Standards for the Construction Industry) and California Code of Regulations, Title 8, Section 1529 Asbestos, and Subchapter 4. Construction Safety Orders

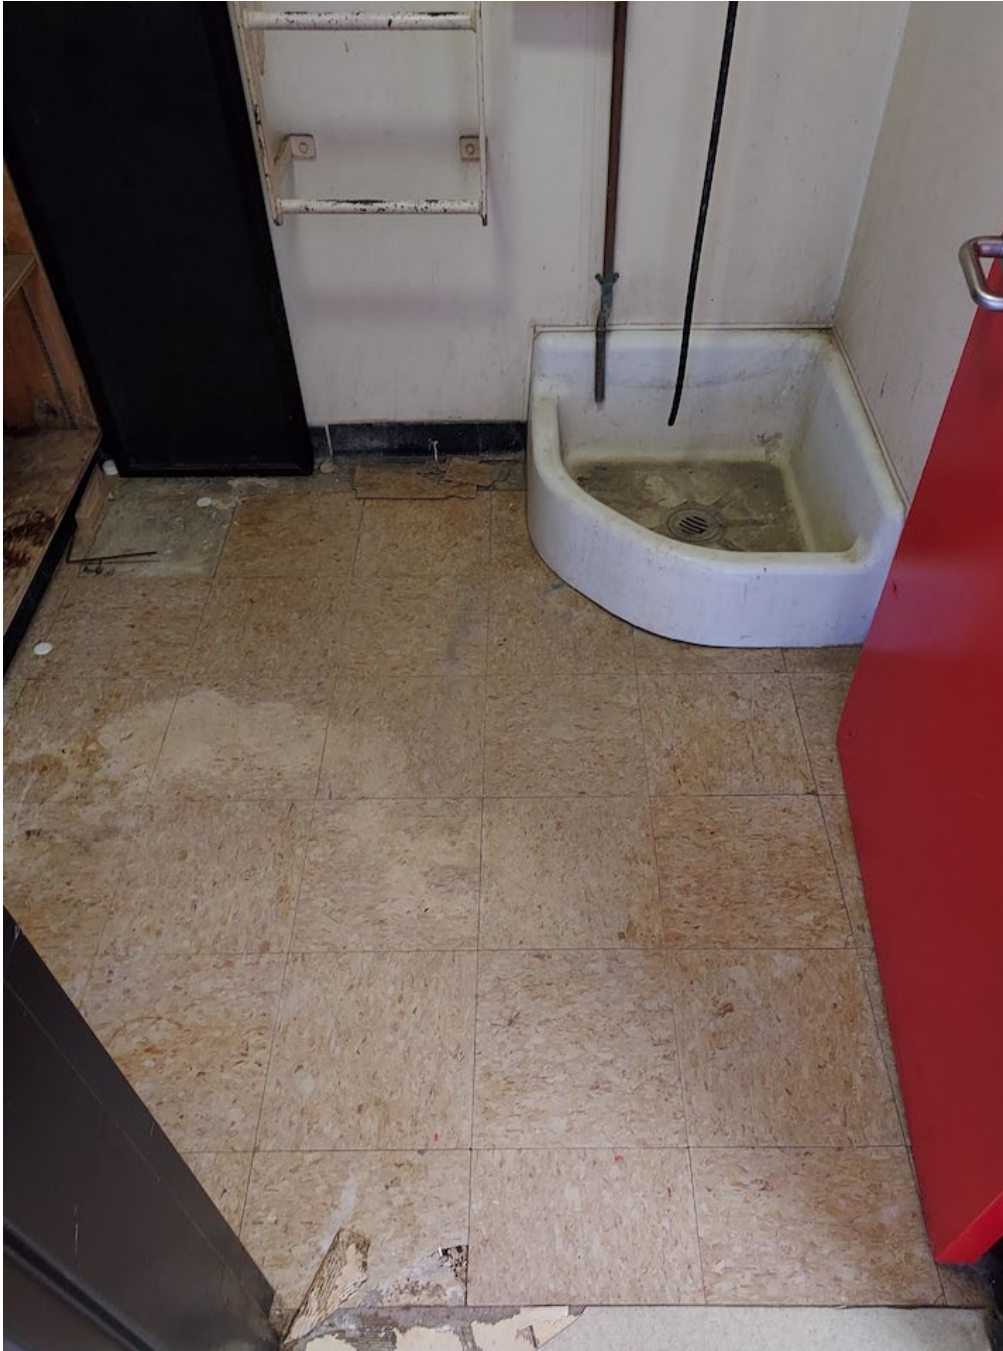
- Beige with green specks vinyl sheet flooring observed at the hallway entrances.
- Orange 12"x12" vinyl floor tiles observed in the janitor's closet, IT closet, and storage.

- *This component contained 2% chrysotile asbestos* (Picture, §6.0-c)
- Gray with dark specks vinyl sheet flooring observed under water fountain in east N-S hallway.

c) Orange 12"x12" vinyl floor tiles in the janitor's closet, IT closet and storage in Building C were found to contain asbestos.

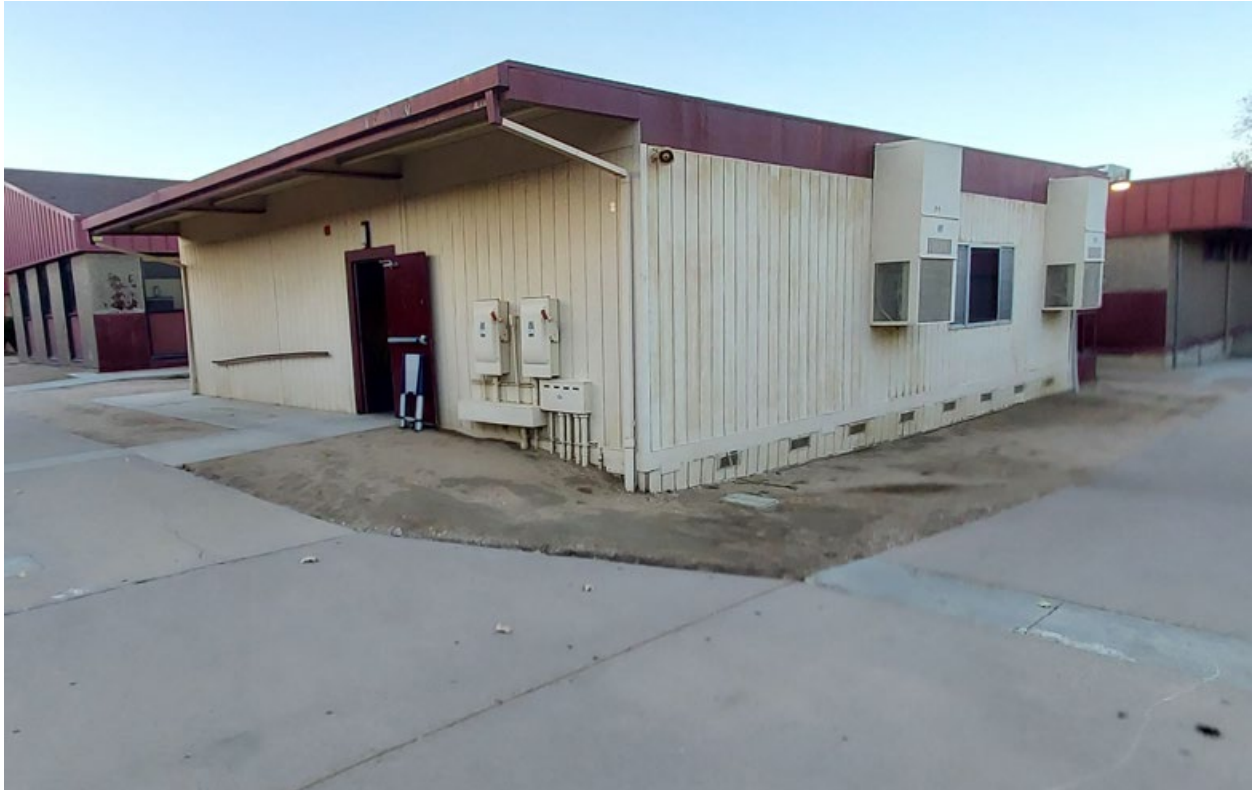
- Exterior walls were observed to be wood with vapor barrier underneath. (Picture, §6.0-d)
- The structure was observed to be sitting on wooden stilts foundation.
- The interior was one large room with 2 bathrooms separate from the room (*Bathroom-2 was inaccessible at time of inspection*).
- Bathroom-1 had plastic wall paneling with mastic and the floors were vinyl sheet flooring.
- Room-1 had wood walls, carpet flooring with mastic, and cove base with mastic on the walls.
- 2'x4' acoustic ceiling tiles were observed in Room-1.
- Fiberglass insulation was observed above the plenum space and was not sampled as this is not a suspect material.
- The roof system was a rolled asphalt roof.

d) Exterior of Bungalow P1
